Town of Osoyoos Accessibility Audit:

Final Report

January 11th, 2013

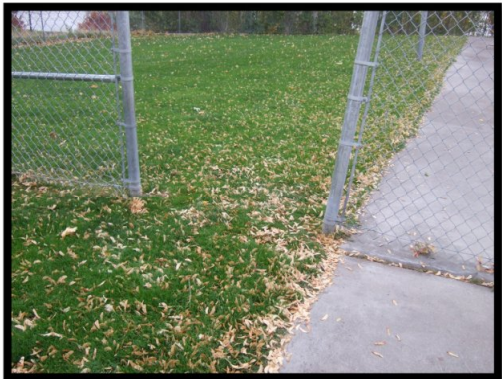
Photo 2: Sonora Centre – Inaccessible pathway from parking lot to basketball court

Some community members may wish to park at the Sonora Community Centre and walk over to the basketball court. Accessibility could be enhanced by providing a paved pathway to the basketball court that is at least 36” wide, as well as an accessible viewing area alongside the court. This would make it possible for people with disabilities to use the basketball court and watch their children play basketball.

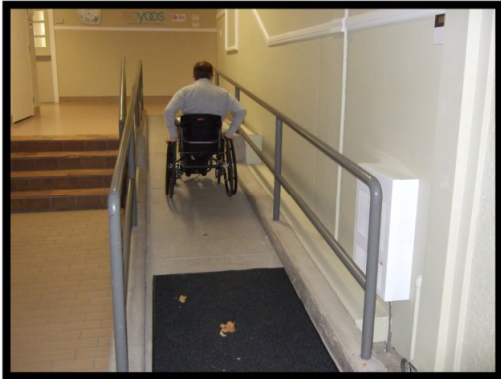
Photo 4: Sonora Centre – Ramp by east entrance

The current ramp has a slope of approximately 1:12 which meets minimum accessibility standards, but is a bit challenging for someone with limited upper body strength to use. Ramps with a slope of 1:20 are more accessible. That being said, it is not always possible to install a ramp with a slope of 1:20 in a renovated building like the Sonora Centre. Thus, the best course of action is to plan to provide ramps with a slope of 1:20 in all new facilities.

Recommendation: Provide more gradual ramps in future facilities

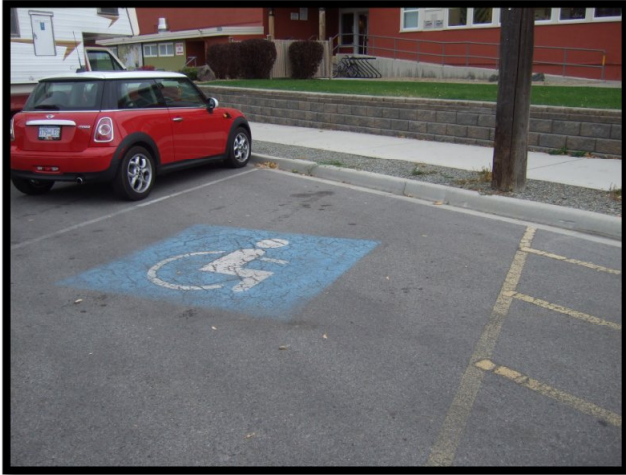
Photo 6: Sonora Centre – Parking stall by north entrance

In order for an accessible parking stall to be fully accessible, it needs to be well marked so that people without disabilities do not accidentally park there. In order to be well marked, it needs to have both a painted symbol within the stall as well as a sign on a post. It is recommended that a sign post be installed for this parking stall.

Recommendation: Improve signage for accessible parking stall by north entrance

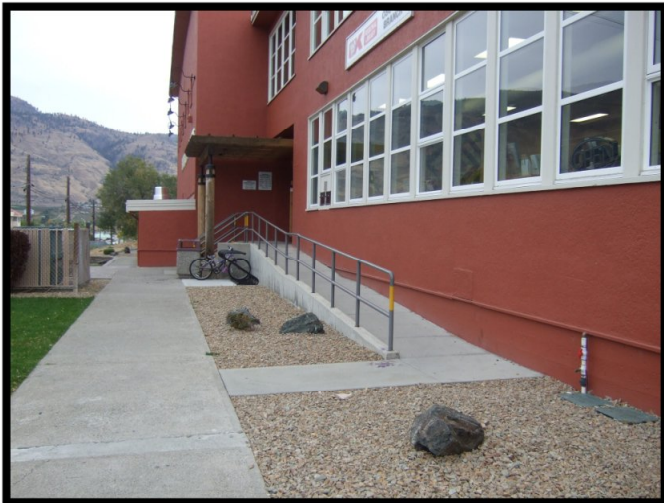
Photo 7: Sonora Centre – Ramp by north entrance

Key Finding: The north entrance is relatively accessible

The north entrance is relatively accessible because there is a ramp with a gradual incline and an automatic push button at the entrance.

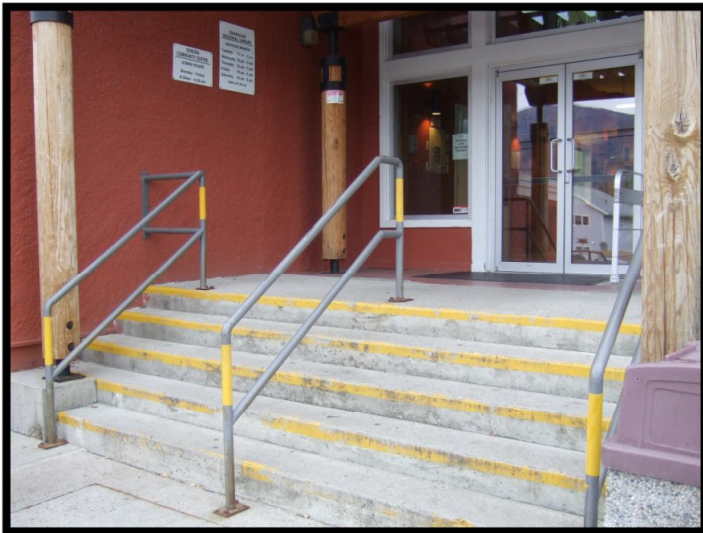
Photo 8: Sonora Centre – Staircase by north entrance

The current staircase by the north entrance lacks *tactile* warning strips on the stair nosings which warn people with low vision about a change in elevation. The painted yellow strips would not be detectable for someone who is fully blind. According to Canadian National Institute for the Blind (CNIB), nosings should: have a colour/brightness contrasted strip; have a maximum depth of 50 mm; and be applied to the leading edge of the tread and the vertical face of the nosing.

Recommendation: Provide tactile warning strips on staircase by north entrance

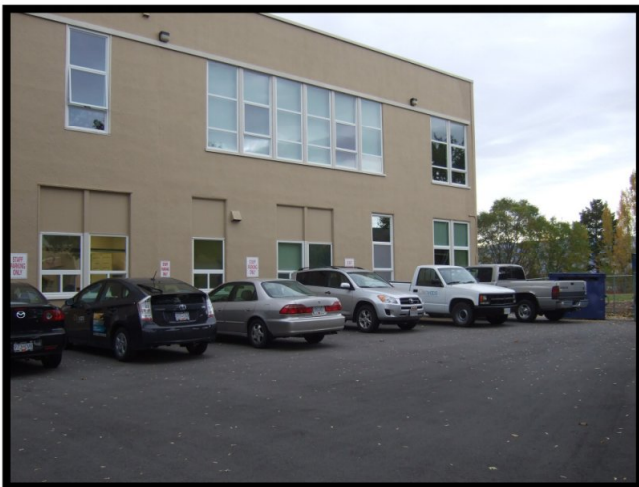
Photo 9: Sonora Centre – Staff parking lot

The staff parking lot currently lacks an accessible parking stall for employees/volunteers with disabilities. It is recommended that an accessible parking stall be created for staff/volunteers with disabilities.

Recommendation: Provide an accessible parking stall in the staff parking lot

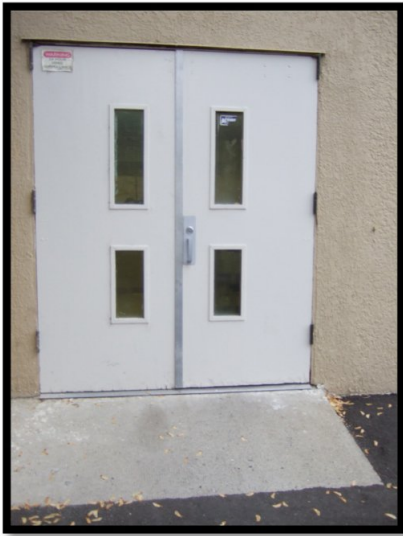
Photo 10: Sonora Centre – Entrance by staff parking lot

The entrance leading from the staff parking lot into the Sonora Centre is currently inaccessible because:

Recommendation: Explore the feasibility of improving the accessibility of the staff entrance

It is recommended that the Town explore the feasibility of addressing these accessibility barriers for staff/volunteers with disabilities.

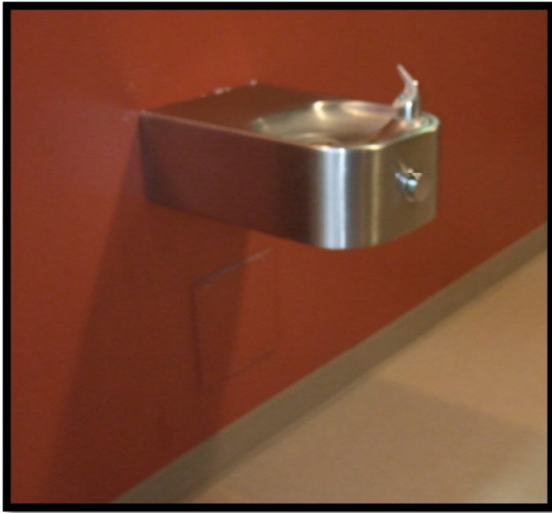
Photo 13: Sonora Centre – Accessible water fountain

Key finding: The water fountain is both wheelchair accessible and cane detectable for people with low vision

The water fountain is accessible for someone seated in a wheelchair because it is possible to pull up underneath. In addition, the protruding water fountain is also cane detectable because it is located at an accessible height. The lowest leading edge is positioned 660 mm above the ground, and objects with a lowest leading edge under 680 mm are cane detectable (Note: if an object protrudes at a level higher than 680 mm and below 2300 mm, the object can be made cane detectable if a railing, planter, or another barrier is placed at or below 680 mm from the walking surface).

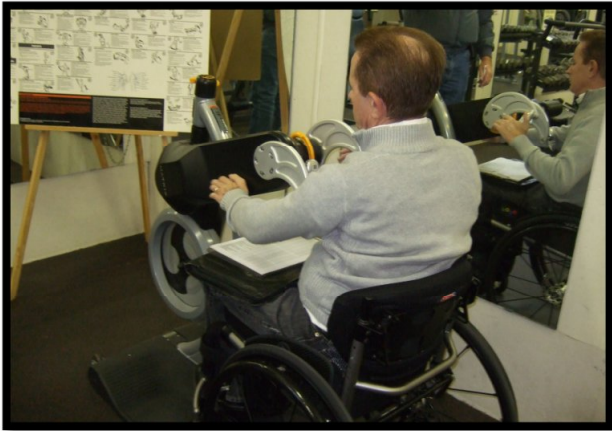
Photo 16: Sonora Centre – Hand cycle in weight room

The hand cycle is almost accessible for someone using a wheelchair, because it can be adjusted for different heights, etc. However, the base of the machine has some ridges which make it a challenge for someone seated in a wheelchair to wheel in and out independently. Accessibility could be enhanced by providing a smooth base.

Recommendation: Adjust the base of the hand cycle

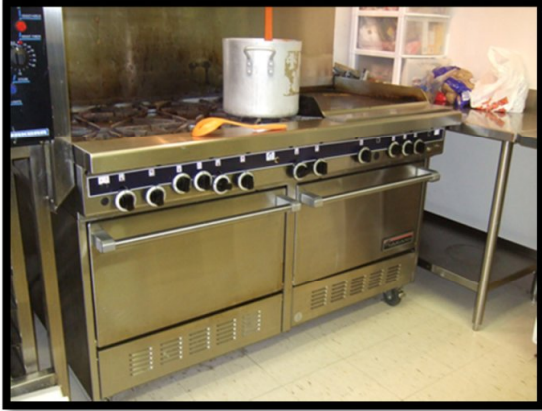
Photo 20: Sonora Centre – Stove with hand controls on front

Some aspects of the kitchen are very accessible. For instance, the hand controls on the front of the stove are easier to reach for people seated in wheelchairs.

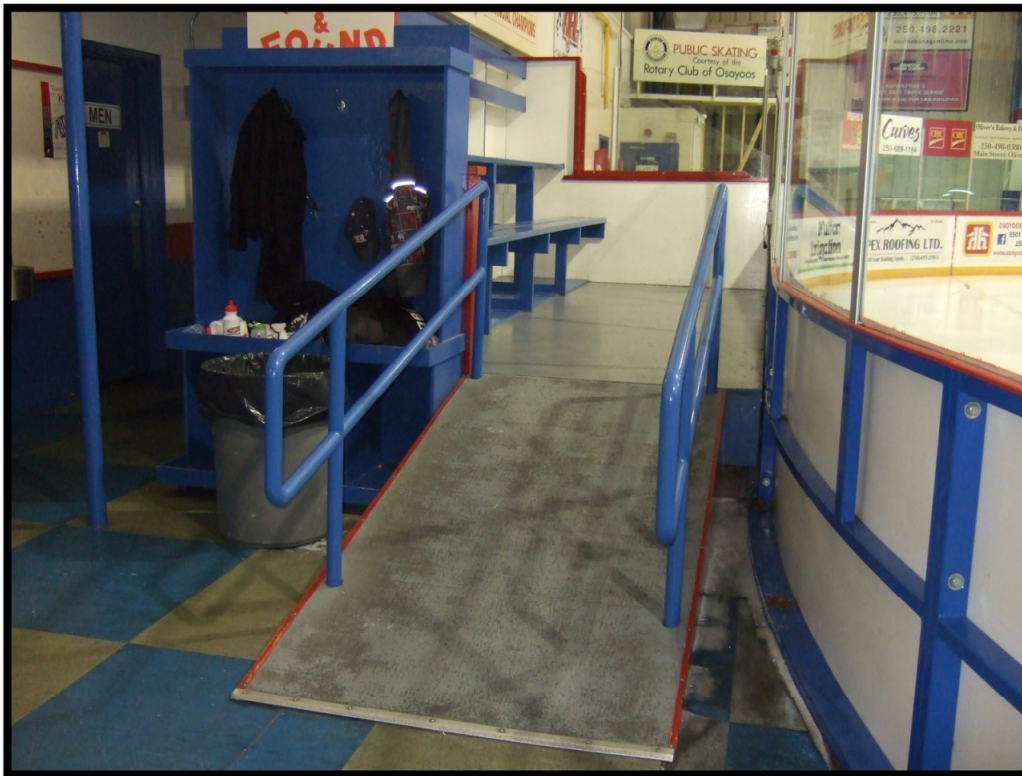
Photo 23: Sun Bowl Arena – Accessible viewing area

One limitation of the accessible viewing areas is that the ramp leading up to it is a bit steep. As a result, most people using manual wheelchairs would need to ask a friend, family member, or other community member to push them up to the top of the ramp. Thus, it is recommended that the Town explore the feasibility of replacing the current ramp with a longer ramp with a slope of 1:20.

Recommendation: Explore the feasibility of providing a ramp with a slope of 1:20

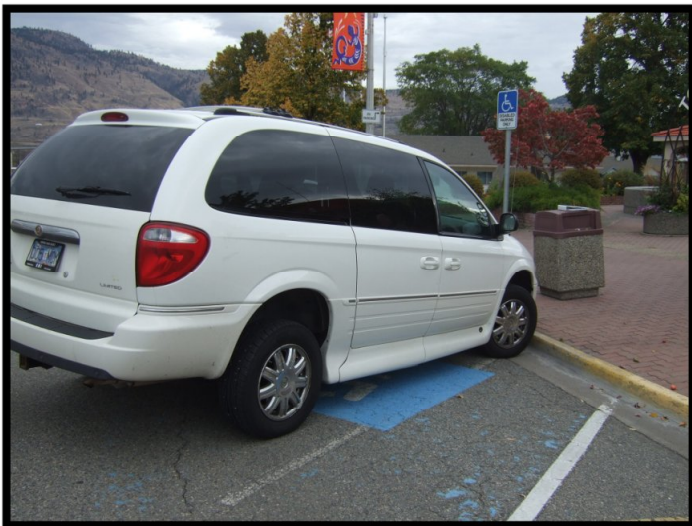
Photo 32: Town Hall – Accessible parking stall

The current angled accessible parking spot can be a challenge to use because of the slope of the road. It can be hazardous for someone to transfer from a car seat to a wheelchair because the chair can roll downhill and it increases the risk of falls. The slope of the road is difficult to address, because it is a provincial roadway and the province has crowning requirements for snow removal.

Recommendation: Improve accessible parking at Town Hall

- Replace the current angled stall with an accessible parallel parking stall;
- Install a curb ramp connecting the newly created parking stall to the sidewalk;
- Ensure the stall is wide enough (3.7 m wide) to allow someone using a wheelchair to transfer in and out of their car.

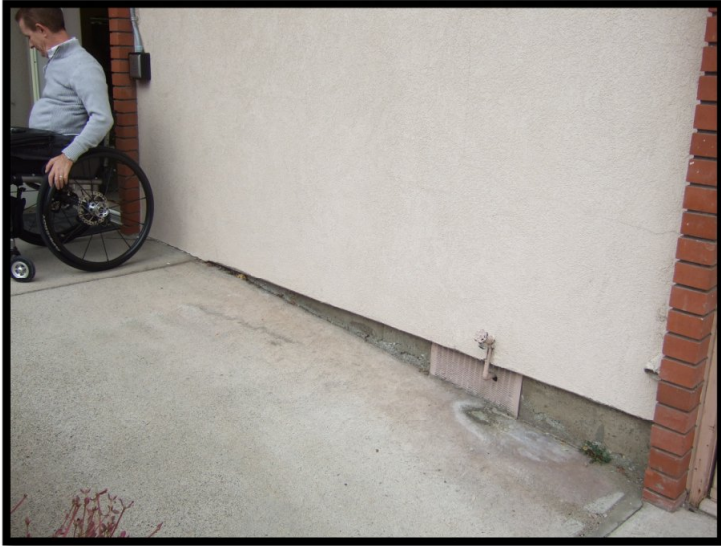
Photo 35: Town Hall – Base of ramp leading to Council Chambers

Photo 36: Town Hall – Upper portion of ramp leading to Council Chambers

Recommendation: Improve accessibility of ramp leading into Council Chambers

- Repair cracked pavement which limits accessibility of ramp;
- Provide a handrail along the upper portion of the ramp.

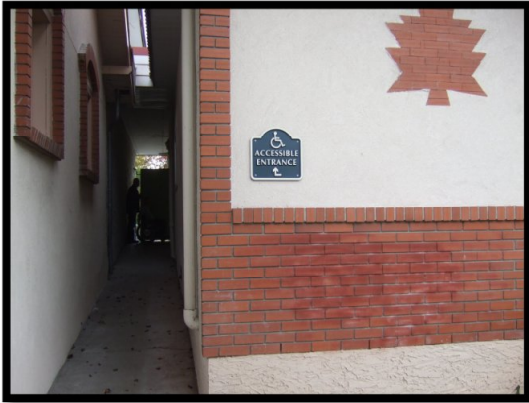
Photo 38: Planning and Development Services – Ramp at accessible entrance with signage

It has a number of accessibility challenges which would prevent many people with disabilities from accessing the entrance safely and independently. For example, there is no handrails alongside the ramp for people to grasp onto for extra support. In addition, the level threshold area at the top of the ramp is unsafe because it is too small and the door opens outwards into the level threshold area. This has a few key safety implications:

- It is unsafe for someone using a wheelchair to wheel up the ramp and open the door independently because they would need to rest on the incline part of the ramp while the door swings open, and thereby risk rolling backwards and injury;
- Similarly, it is unsafe for someone using a wheelchair to wheel up the ramp and use the call button for assistance, because the opening door would hit the person seated in a wheelchair

who is sitting on the threshold area, or the individual would need to rest on the incline portion and risk rolling backwards and injury.

Recommendation: Improve safety of accessible entrance

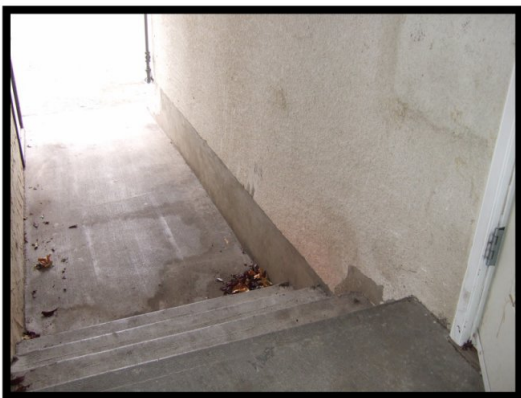
Another accessibility challenge is the staircase/drop off on the other side of the level threshold that is not well marked for people with low vision.

Photo 40: Planning and Development Services – Hazard at top of ramp

Because of the age of the building, it would be a challenge to renovate it to meet current accessibility standards. Ideally, the Planning and Development Services Office would be moved to a more accessible location in the future.

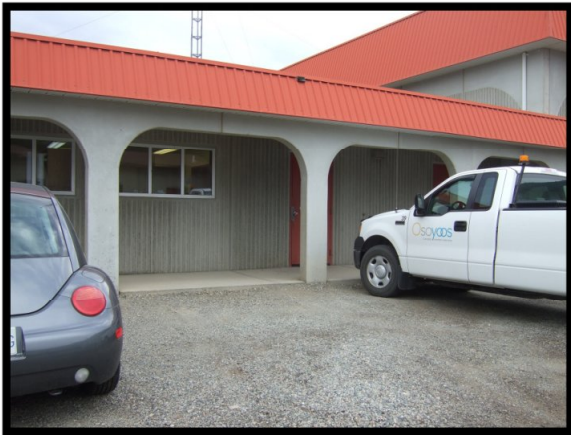
Photo 41: Public Works office – Gravel parking lot

The parking lot for the public works yard is loose gravel. In some areas, it is coarse, loose gravel which would block access for many people with disabilities. In other areas it is more finely ground gravel which is accessible. A paved parking lot would provide the highest level of accessibility for local residents who are visiting the Public Works office. Providing designated accessible parking would also prevent others from parking beside a vehicle and blocking the accessible transfer space for that individual.

Recommendation: Provide accessible parking

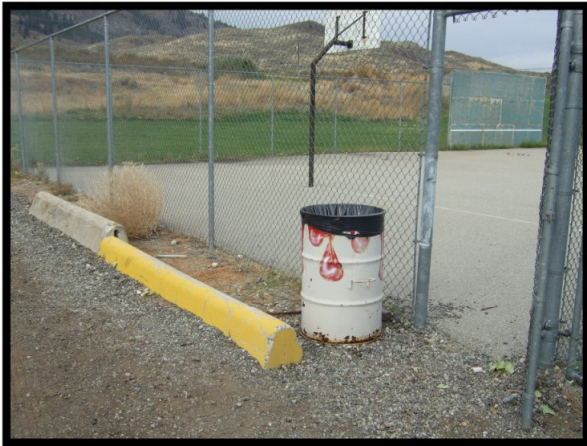
Photo 43: Basketball Court – Entrance

The current entrance to the basketball court is not accessible because it is too narrow. It is recommended that an accessible entrance that is at least 915 mm wide be provided, and that the area in front of the entrance be kept free of loose gravel.

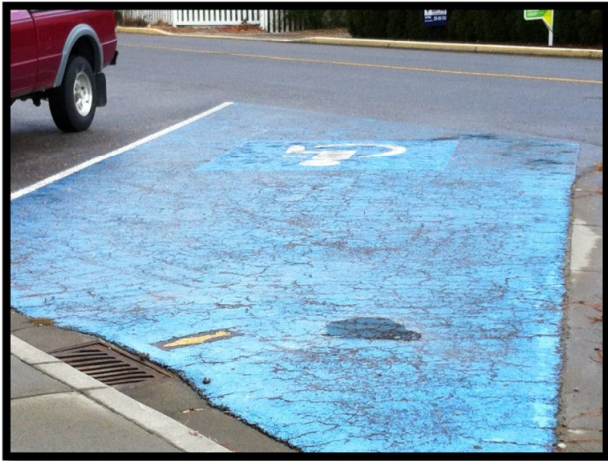
Photo 45: Cottonwood Park – Accessible parking stall

The accessibility of the parking stall could be enhanced by providing a sign on a post (in addition to the painted symbol in the stall) because it would make it less likely that someone would inadvertently park in the accessible parking stall.

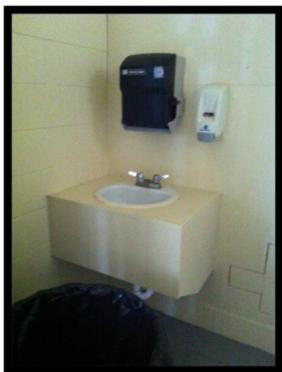
Photo 46: Cottonwood Park – Inside of washroom

Cottonwood park is an older park, and the washrooms were constructed before the BC Building Code took into consideration accessibility. As a result, they are completely inaccessible for people with disabilities and lack accessibility features such as space to maneuver, grab bars, and knee space underneath the sink. Thus, it is recommended that the washrooms be renovated so that they meet current accessibility standards.

Recommendation: Retrofit the washrooms with accessibility mind

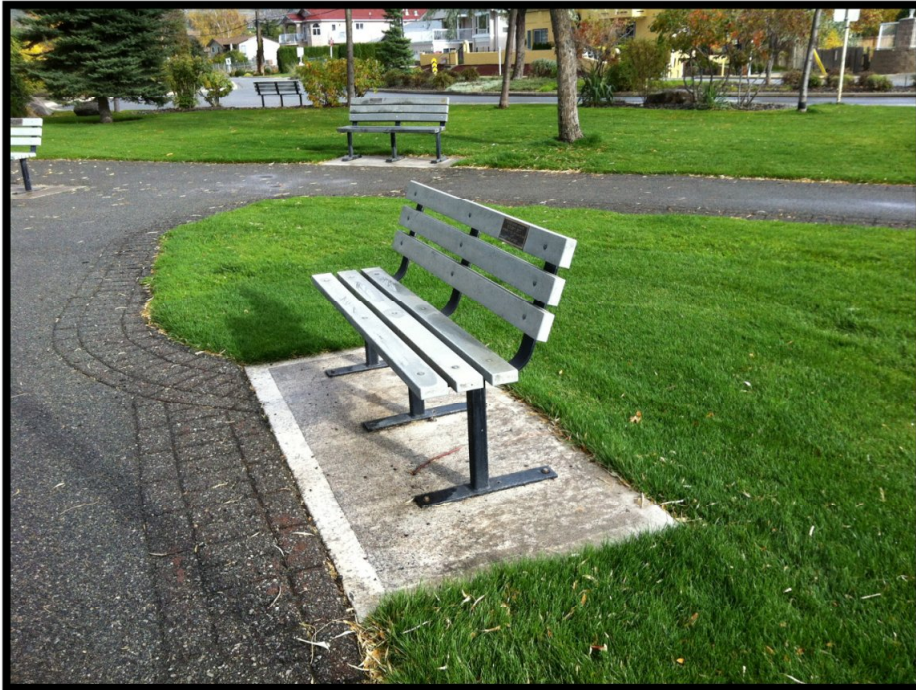
Photo 47: Cottonwood Park – Pathway and bench

Key Finding: The pathways are relatively accessible

The pathways throughout the park are relatively accessible for people with disabilities, because they are level and have an accessible paved surface. In addition, all the key activity areas of the park are well connected by accessible pathways, including washrooms and benches.

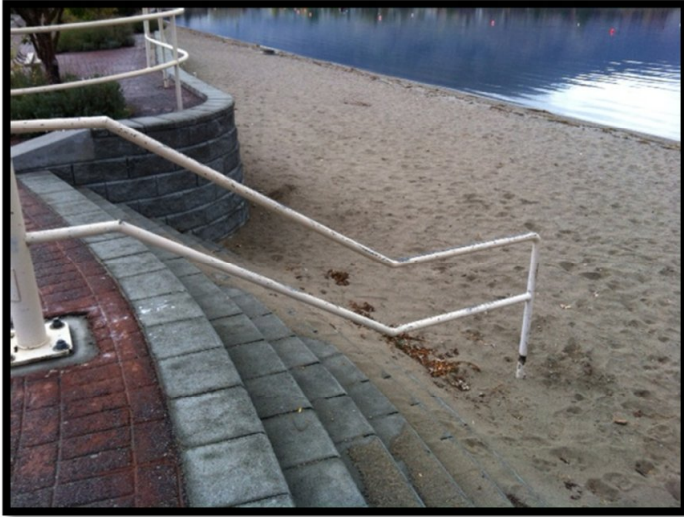
Photo 48: Cottonwood Park – Staircase

The current staircase has some accessibility features for people with low vision including handrails as well as a change in texture between the pathway and the staircase (which helps to warn people with low vision about a change in elevation). However, the individual stairs lack tactile warning strips which warn people with low vision about the end of each step. It is recommended that tactile warning strips be incorporated into the staircase.

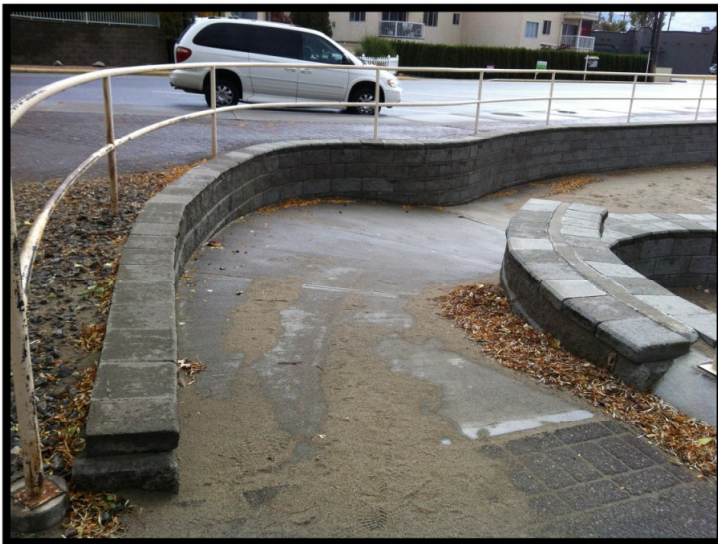
Photo 49: Cottonwood Park – Ramp to the beach

Key finding: The ramp is accessible

Cottonwood Park provide an accessible ramp leading down to the beach. This ramp is accessible because of its gradual incline; hand rails, the tactile warning strip at the top of the ramp. This is an excellent design feature because a person with a disability with access to a flexible rubber runner, or beach mat would be able to reach the water’s edge which meets the highest level of accessibility for beach access.

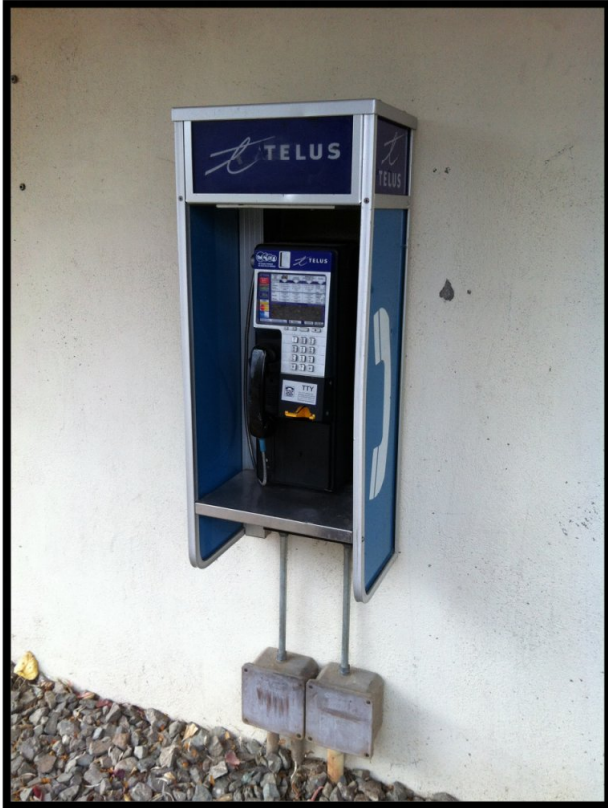
Photo 50: Cottonwood Park – Payphone with TTY

Key finding: The payphone with TTY enhances accessibility for people who are Deaf

The payphone with TTY enhances accessibility for people who are Deaf or Hard of Hearing because it allows users with a TTY device to transmit text over telephone lines.

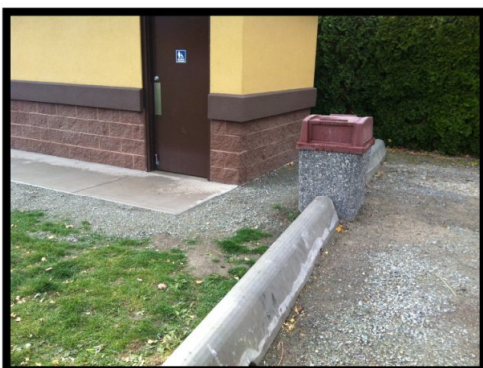
Photo 52: Goodman Park – Pathway to accessible washroom blocked by concrete curb

In order for a park to be fully accessible, there needs to be accessible pathways linking different amenities (e.g. parking, washrooms, picnic tables, benches etc.). These accessible pathways need to have an accessible surface (e.g. pavement, crushed aggregate) and be free of obstructions. The gravel surface of the parking lot, and the grass surface of the park would be difficult or impossible for most people using mobility devices to travel over. In addition, the concrete curbs in the parking lot prevent there from being an accessible pathway connecting the washrooms to the parking lot. There needs to be an accessible pathway that is at least 915 mm wide (that cannot be blocked by a parked car) in order to provide access to the washrooms for people with disabilities.

As was previously mentioned, it is also essential to provide an accessible pathway to the washroom that is not blocked by the concrete curb.

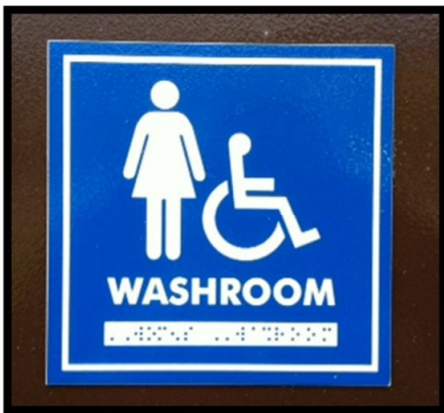
Photo 53: Goodman Park – Braille washroom sign

The new washrooms were built to a high standard of accessibility and incorporate accessible features such as: Braille/Raised lettering signage; accessible entrances; loop style door handles; grab bars; sinks with knee clearance; easy to operate hand controls; and transfer space alongside the toilet.

Recommendation: Make minor accessibility improvements to the washroom

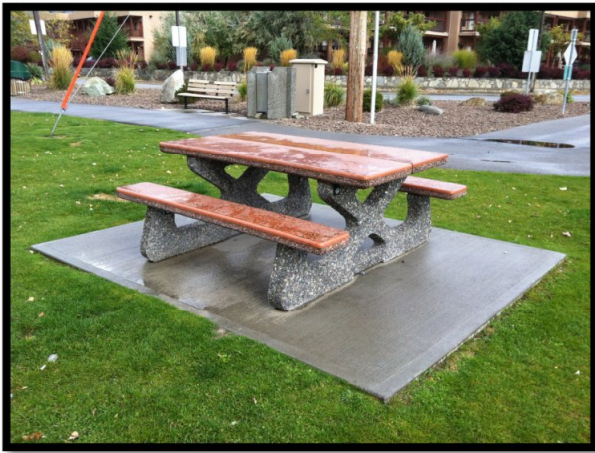
Photo 55: Goodman Park – Picnic table

In order for a picnic table to be accessible, it needs to have an accessible path of travel leading up to it; an extended table top that allows a person seated in a wheelchair to wheel underneath; and a clear space of 1200 mm surrounding it.

Recommendation: Provide accessible picnic tables and benches

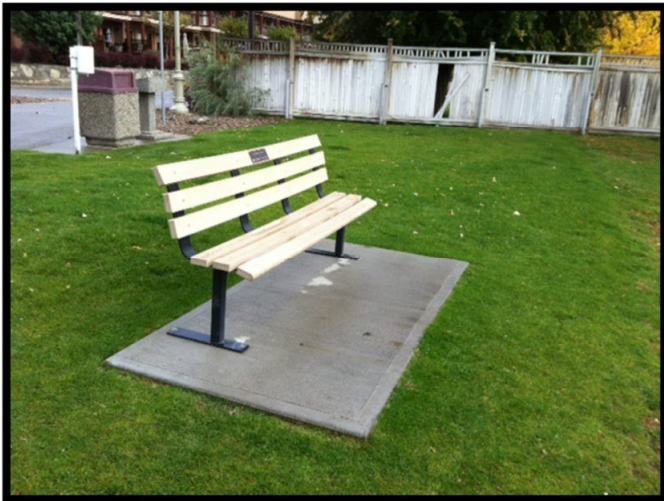
Photo 56: Goodman Park – Bench

In order for a bench to be accessible, it needs to have an accessible path of travel leading to it, as well as an accessible clear space beside the bench for a person in a wheelchair to sit alongside friends and family.

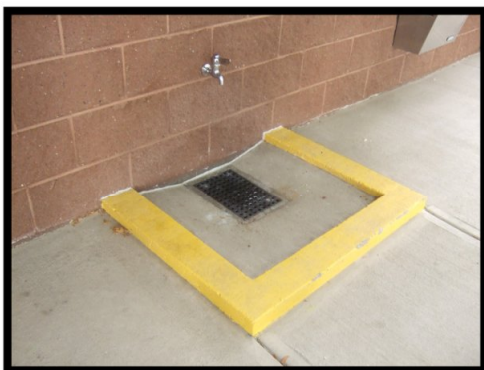
Photo 58: Gyro Park – Water faucet

The water faucet has a raised concrete border surrounding it, which creates a tripping hazard for people with low vision. While the yellow paint increases visibility, it would be more accessible if this concrete border was not in place.

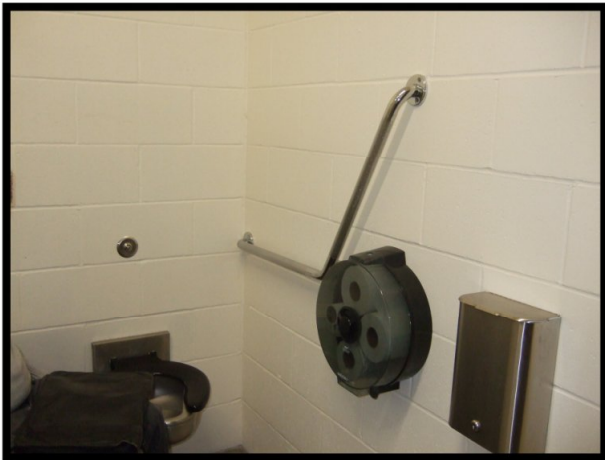
Photo 59: Gyro Park – Accessible washroom stall

Because the newly constructed washrooms were built with accessibility in mind, they already meet most accessibility requirements. Some examples of things done well include: level entrances, knee space underneath the sink; adequate space for wheelchair users to maneuver; soap/paper towel dispensers that are easily reached, etc.

- Install a tactile washroom sign with Braille/raised lettering for people with low vision;
- Install a kick plate on washroom doors to protect the door;
- Provide a grab bar behind the toilet since there is no toilet water tank for someone to grasp onto as they transfer from the toilet to their chair.

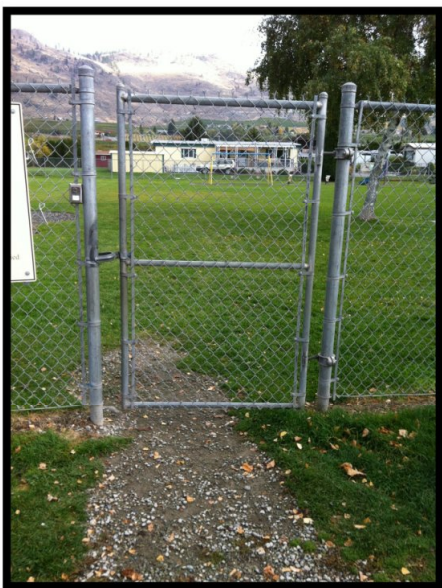
Photo 61: Kinsmen Park – Entrance

It would be a challenge for most people using mobility devices to travel over the grass, and loose gravel surfaces of Kinsmen Park.

Recommendation: Provide accessible pathways linking key amenities throughout the park

- an accessible surface (e.g. pavement, compacted crushed aggregate);
- minimal slope (1:20 or less) and minimal cross slope;
- a width of at least 920 mm
- no hazards or barriers.

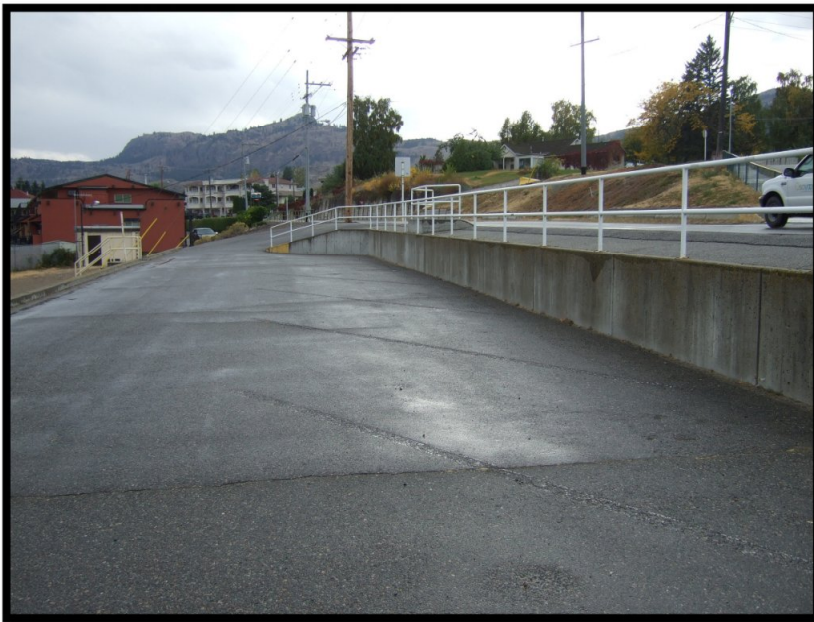
Photo 64: Legion Beach – Parking lot

Legion Beach park currently does not offer any accessible parking stalls to visitors with disabilities. It is recommended that one be constructed that is 3.7 m wide and 7.5 m deep (including a 1.2 m wide walkway). It should also be located on a level surface and be well marked by accessible signage.

Recommendation: Provide accessible parking

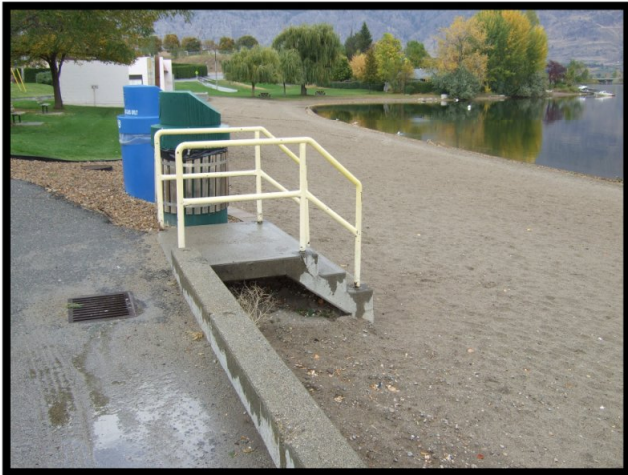
Photo 65: Legion Beach – Stairs connecting parking lot to the beach

There are no accessible pathways linking the parking lot to other activity areas. For example, there is only a flight of stairs leading down to the beach and no ramp. There is also a lack of accessible surfaces for pathways since both loose sand and grass are inaccessible surfaces for people using mobility devices.

Recommendation: Provide accessible pathways connecting all activity areas (washrooms, benches, beach) and accessible benches and picnic tables

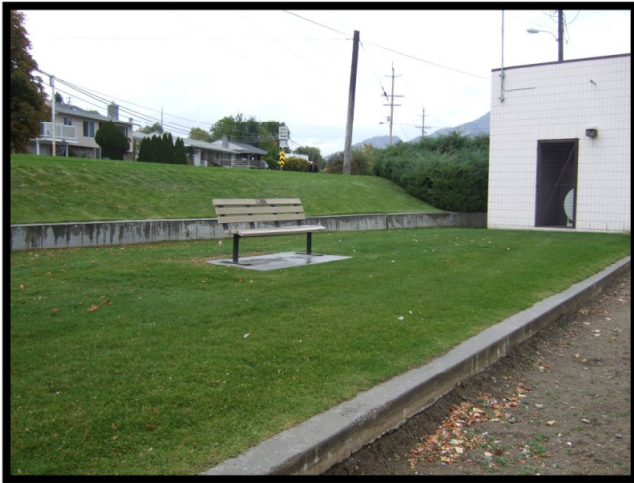
Photo 66: Legion Beach – Inaccessible pathway leading to the bench

The bench is completely inaccessible because there is a step and sandy/grassy pathway leading to it. The picnic table is also completely inaccessible because there is only a grassy pathway leading to it, and it lacks accessibility features such as an extended table top.

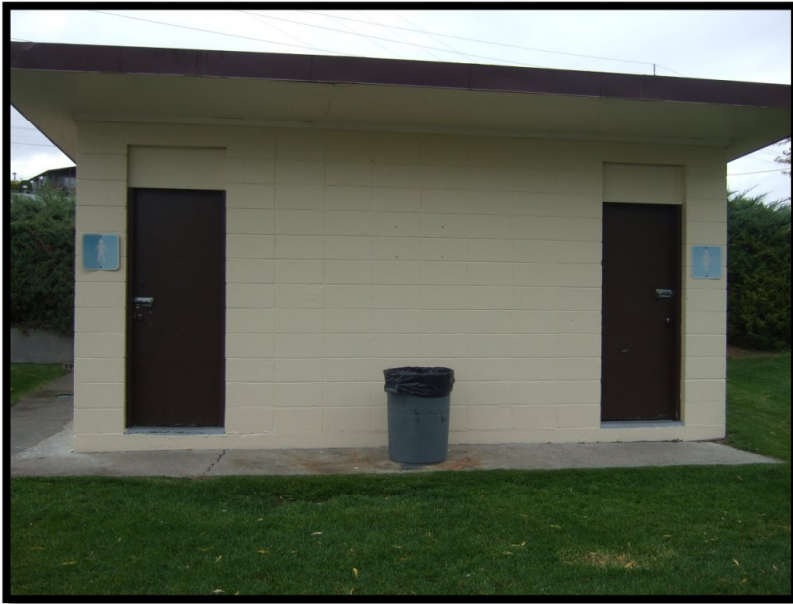
Photo 68: Legion Beach – Washrooms with front step

Recommendation: Retrofit the washrooms with accessibility in mind

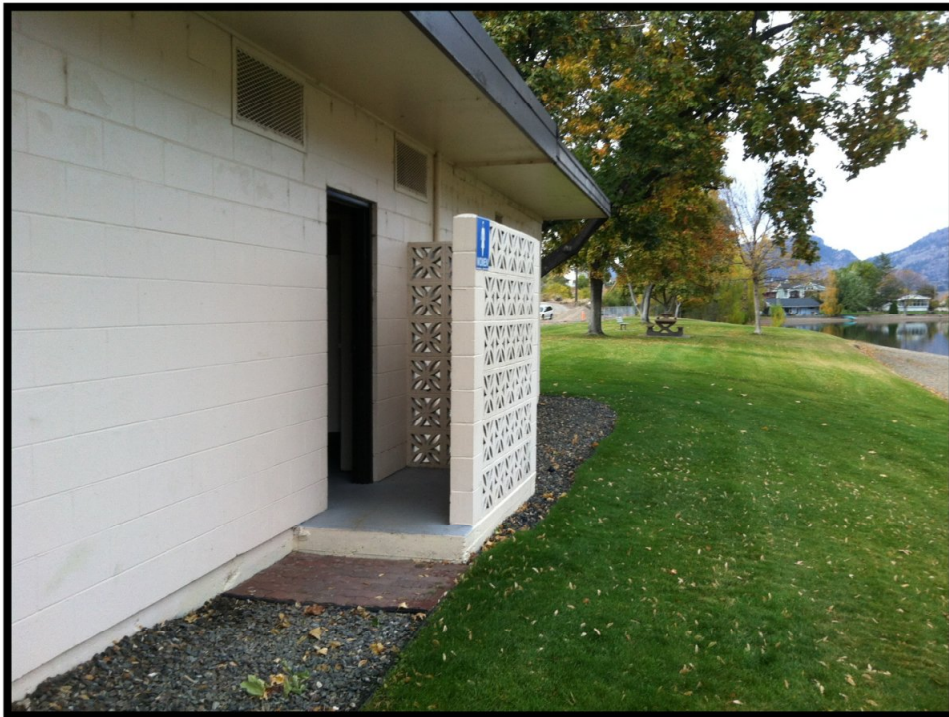
Photo 69: Lions Park – Washroom with step and gravel pathway

Recommendation: Provide accessible pathways which link key activity areas

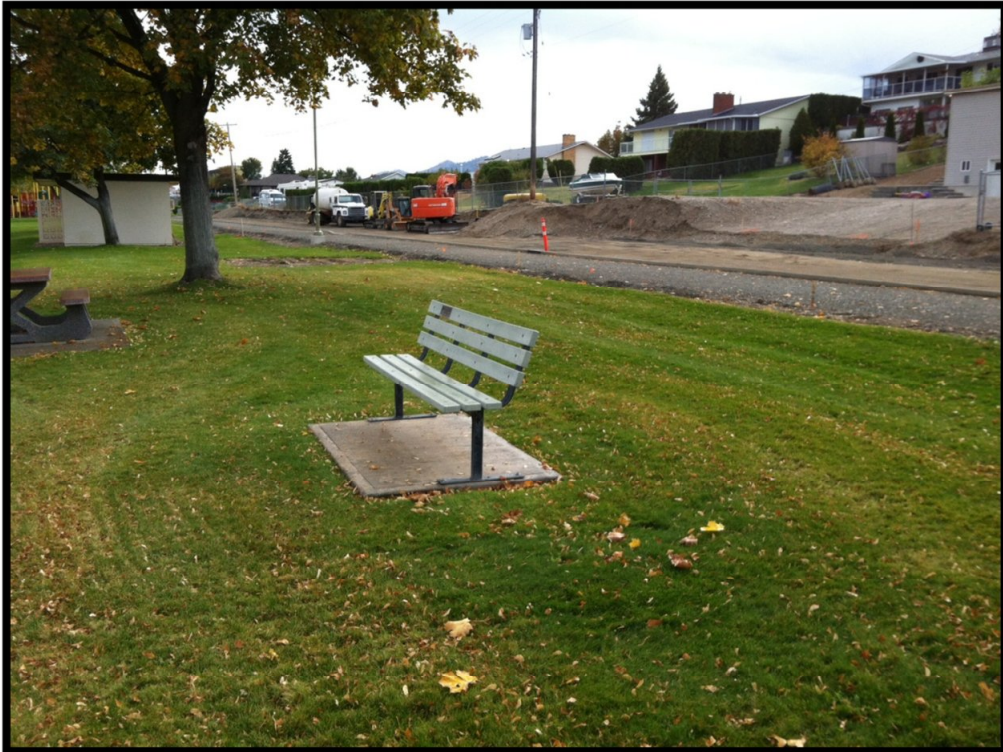
Photo 71: Lions Park – Bench

The accessibility of the park’s benches would be enhanced by providing an accessible path of travel leading to the bench as well as a paved accessible surface beside the bench. This would allow a person with a disability to sit beside their friend or family member on the bench and enjoy the view of the lake. Currently, most people using mobility devices would find it very difficult (or even impossible) to wheel over to the benches.

Recommendation: Provide an accessible bench

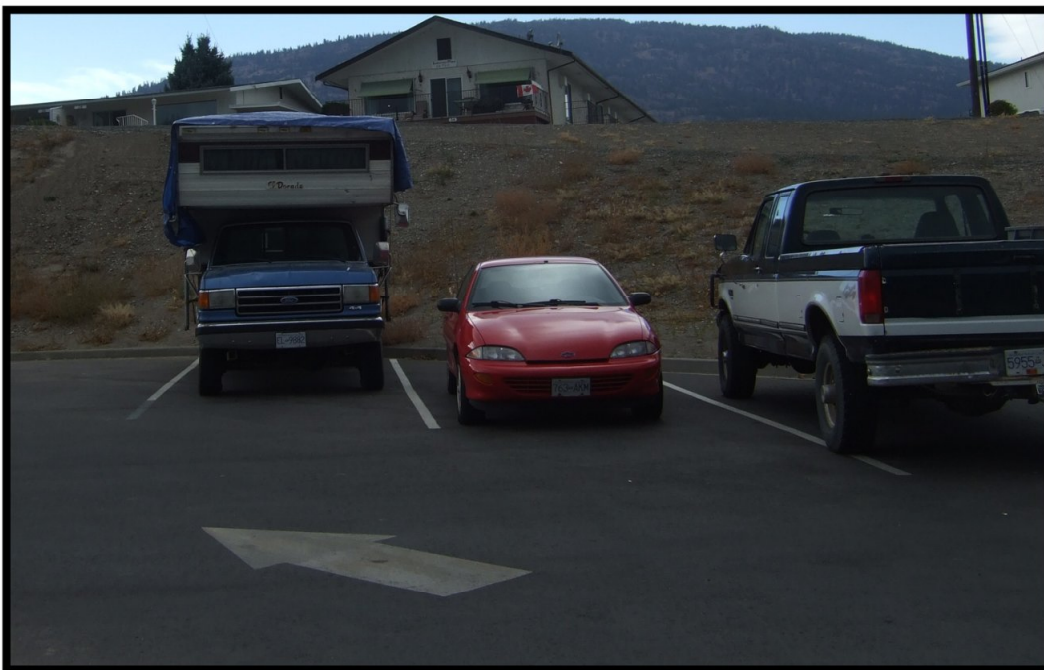
Photo 72: Marina – Potential location for an accessible parking stall

At the time of the audit, the new parking lot by the arena did not provide an accessible parking stall; thus, it is recommended that one be built. The photo below shows a potential location for a parking stall. It is recommended that the parking stall that is furthest on the left be converted to an accessible parking stall. This could be accomplished by widening the stall to be at least 3.7 meters wide, and installing a sign on a post and painting the universally recognized accessibility symbol within the stall.

Recommendation: Provide accessible parking

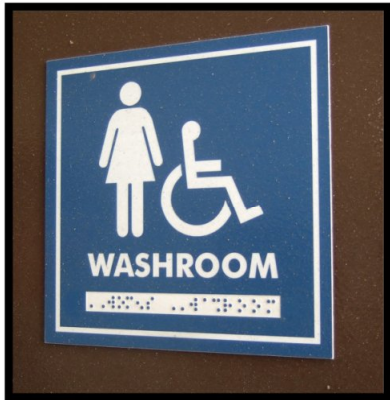
Photo 73: Marina – Braille washroom sign

The newly constructed accessible washrooms were built to a high standard of accessibility and include the following accessibility features: Braille signage for people with low vision; knee space beneath the sink; sufficient space for wheelchairs to maneuver, etc.

While the washroom has been constructed to a high level of accessibility, there are a few recommendations to further enhance accessibility:

- Keep the waste basket outside of the accessible transfer space alongside the toilet;
- Provide a coat hook that is reachable for people seated in wheelchairs;
- Install a grab bar behind the toilet since there is no toilet water tank for people to grasp onto as they transfer from the toilet to chair and vice versa.

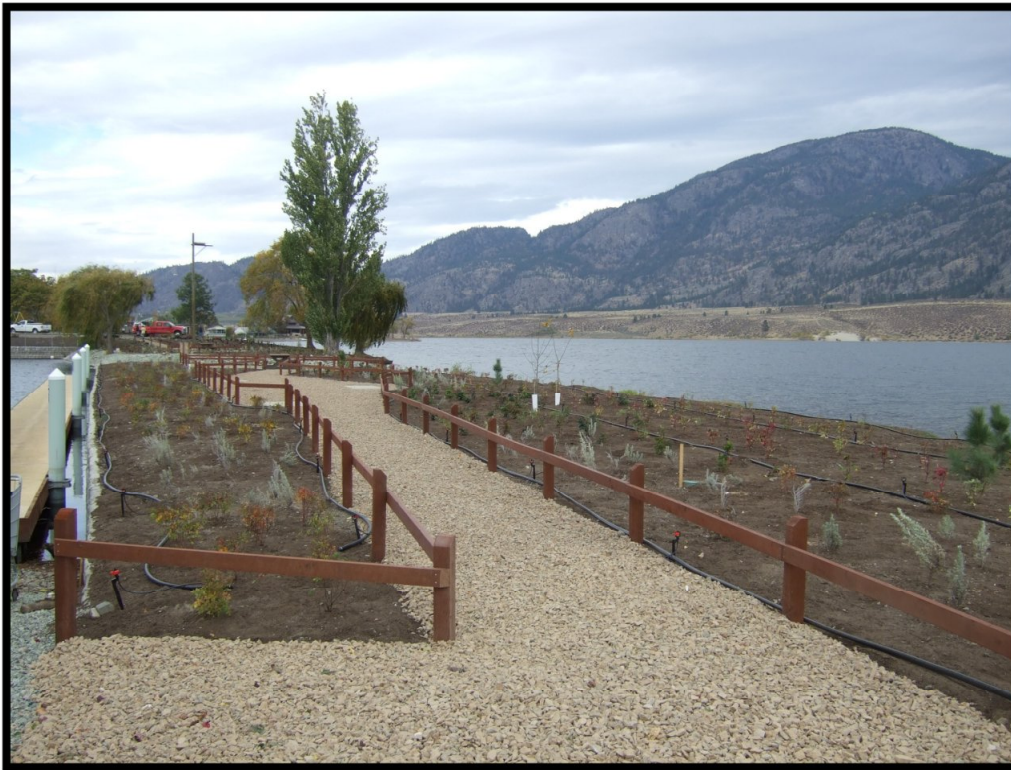
Photo 75: Marina – Inaccessible loose gravel pathway

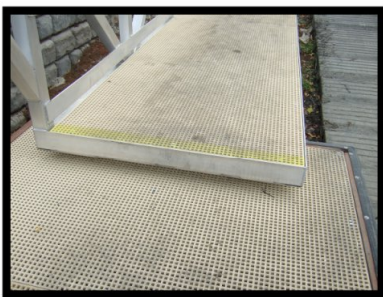
Photo 76: Marina – Abrupt change in elevation on new dock

The marina was still under construction during the time of the audit; however, there were steps leading down to most of the docks and the one ramp that was in place had an abrupt change in elevation, which would block access (see photo below).

Recommendation: Provide an accessible dock

- An accessible pathway leading to the dock;
- An accessible ramp;
- No barriers/hazards;
- Minimum width of 1500 mm;
- Dock heights within 450-600 of the water level to allow easier access to boats;
- Edge protection is 75 mm high;
- Dock edges are emphasized with a colour contrasting strip that is a minimum of 50 mm wide;
- Tiered transfer platforms can be used to access water from dock;
- Extended rail support is helpful for added stabilization when entering boat.

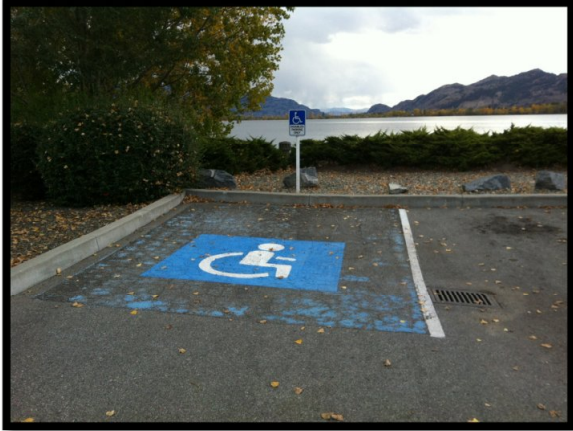
Photo 77: Pioneer Walkway – Accessible parking stall

The parking stall by the pioneer walkway is fully accessible because: it is located on a level surface close to the public washrooms; it has excellent signage with both a painted symbol within the stall and a sign on a post; and it meets accessible parking stall dimension requirements.

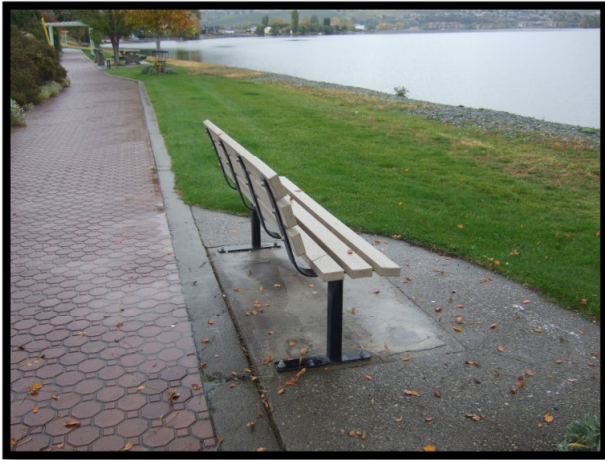
Photo 79: Pioneer Walkway – Accessible bench

The pioneer walkway is relatively accessible since it is spacious, level and has an accessible surface. It also incorporates some great accessibility features such as an accessible bench. The accessible bench provides a paved space beside the bench for a wheelchair user to rest. This allows a person using a wheelchair to comfortably sit beside a friend or family member and enjoy the view of the lake.

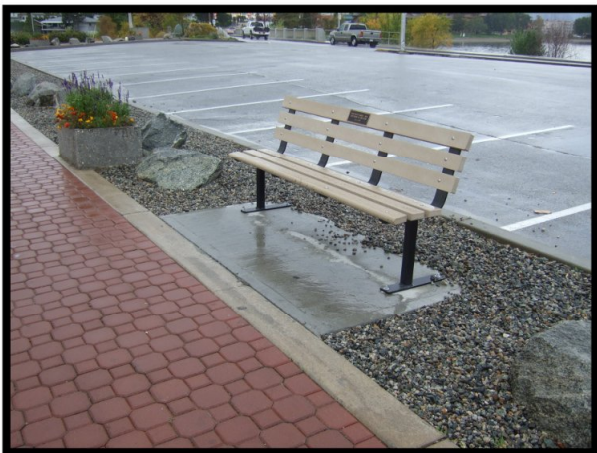
Photo 80: Pioneer Walkway – An example of an inaccessible bench

Recommendation: Provide more accessible benches

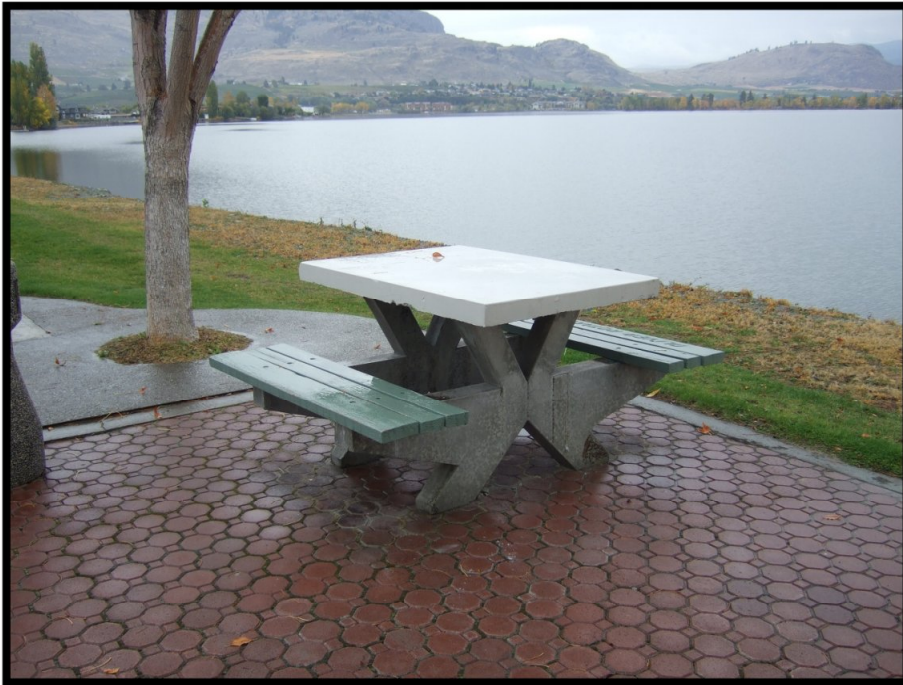
Photo 81: Pioneer Walkway – Inaccessible picnic table

Recommendation: Provide accessible picnic tables

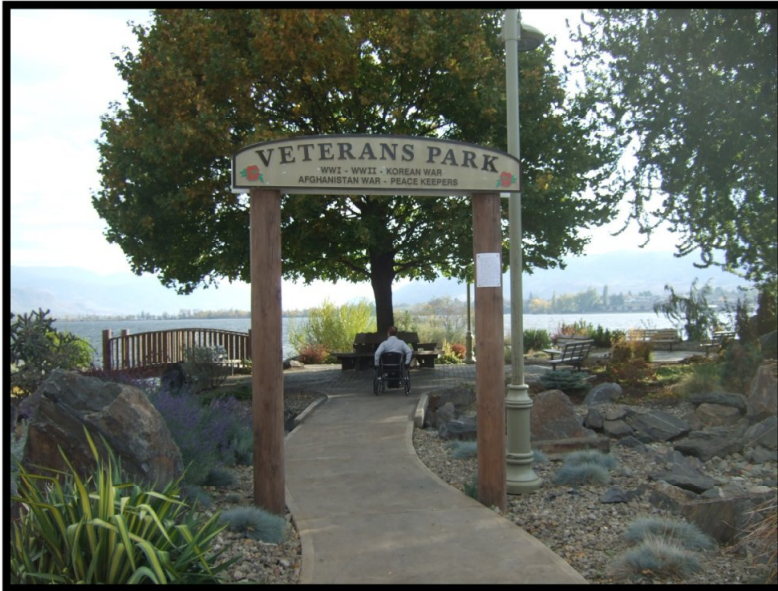
Photo 82: Veterans Park – Entrance

Veterans Park is relatively accessible because there is an accessible entrance, and an accessible pathway leading through the main part of the park where most of the benches are located. The only accessibility limitation is the fact that two of the benches are not connected by an accessible pathway.

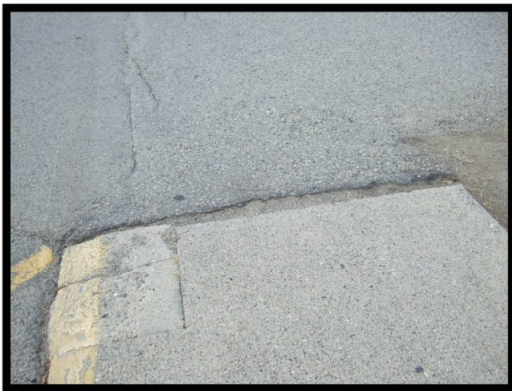
Photo 84: Cracked sidewalk on 78th avenue by the post office

- Repair cracked pavement which creates a safety hazard for people with disabilities at curb ramps and curb cuts.
- Explore adopting the Canadian National Institute for the Blind's guidelines for accessible curb ramps and pedestrian crossing signals.

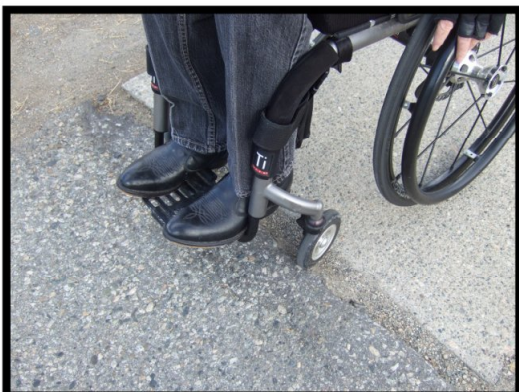
Photo 85: Cracked pavement as a safety hazard

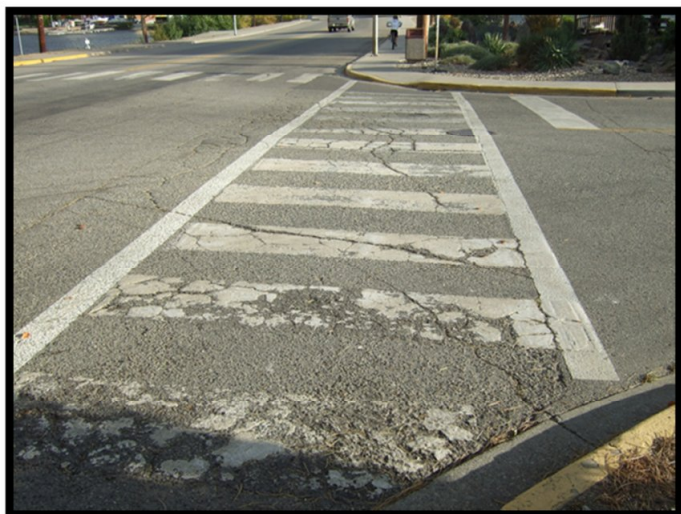
Photo 86: Cracked pavement at Kingfisher Drive crosswalk (by Veteran's Park)

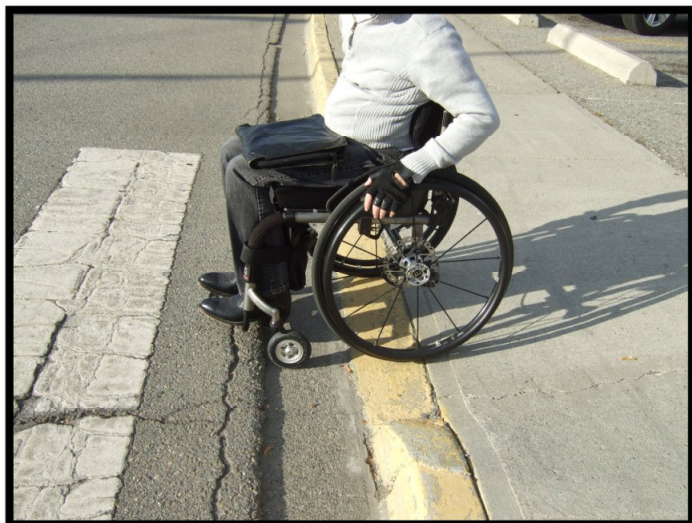
The lip in the pavement at the crosswalk by Family Foods/Pizza Factory also blocks access for people using mobility devices (see photo below). There is a similar accessibility challenge at the crosswalk that crosses Main Street by Kingfisher/Veteran's park.

Photo 87: Lip in pavement blocks access at crosswalk by Family Foods/Pizza Factory
