Town of Osoyoos Accessibility Audit:

Final Report

January 11th, 2013

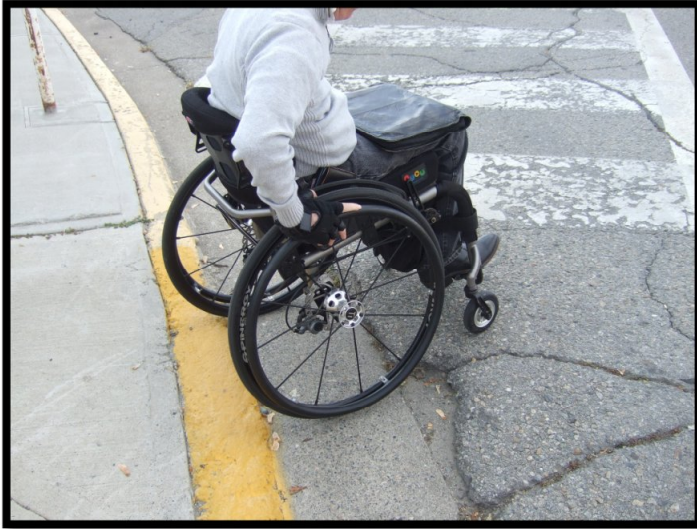
Photo 88: Cracked pavement at crosswalk at 68th Ave and Main Street

- Repair cracked pavement which creates a safety hazard for people with disabilities at curb ramps and curb cuts.
- Explore adopting the Canadian National Institute for the Blind's guidelines for accessible curb ramps and pedestrian crossing signals.

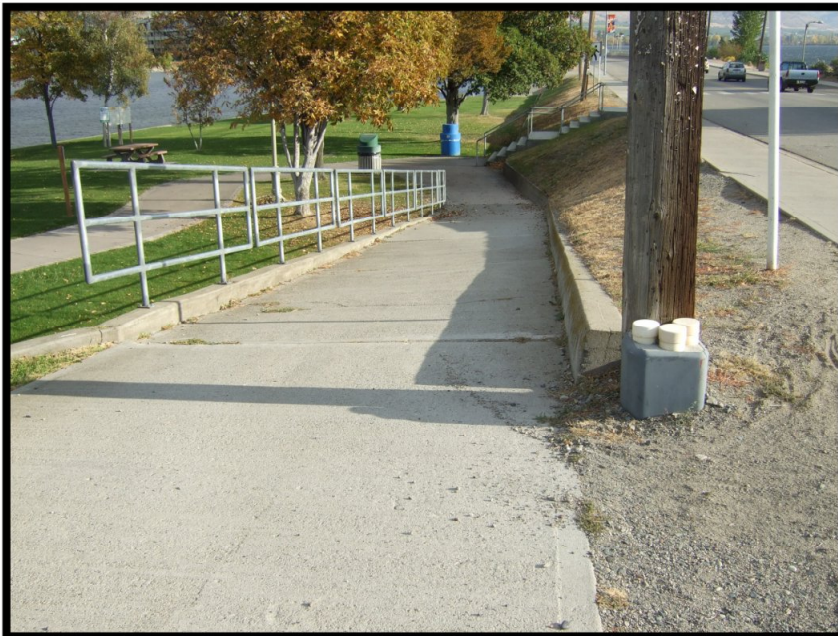
Photo 89: Steep ramp connecting Main Street to Gyro Park by Kingfisher Drive

In some parts of the city, the pathways, sidewalks and/or curb ramps are very steep and inaccessible for some people with disabilities. One example is the ramp which provides access to Gyro Park off of Kingfisher Drive.

Recommendation: Provide gradual slopes and curb ramps wherever possible

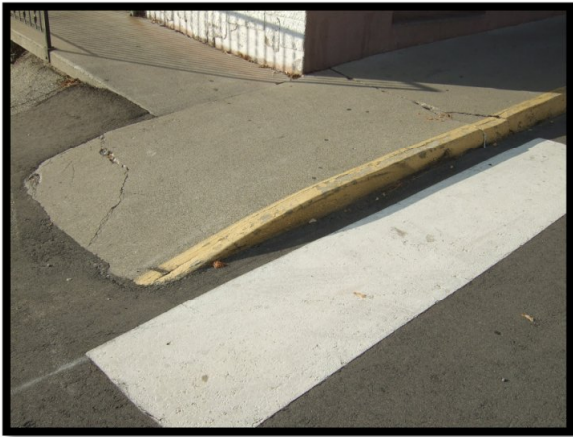
Photo 90: Steep, inaccessible curb ramp by Pizza Factory

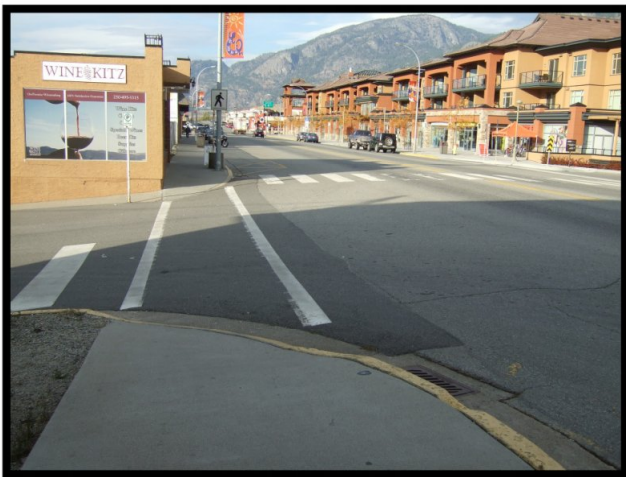
In general, the auditing team found that many of curb ramps running along the older side of Main Street were too steep for wheelchair users.

Photo 91: Steep curb ramps along Main Street

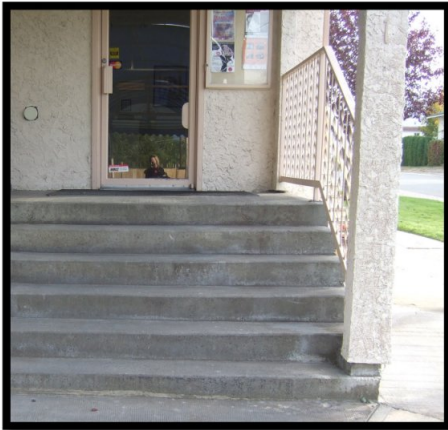
Photo 92: Art Gallery – Main entrance

The current staircase at the main entrance lacks tactile warning strips on the stair nosings which warn people with low vision about a change in elevation. According to Canadian National Institute for the Blind (CNIB), nosings should: have a colour/brightness contrasted strip; have a maximum depth of 50 mm; and be applied to the leading edge of the tread and the vertical face of the nosing. Accessibility could also be enhanced by providing round handrails which are easier to grasp on for people with limited hand dexterity and strength.

Recommendation: Improve accessibility of staircase at main entrance

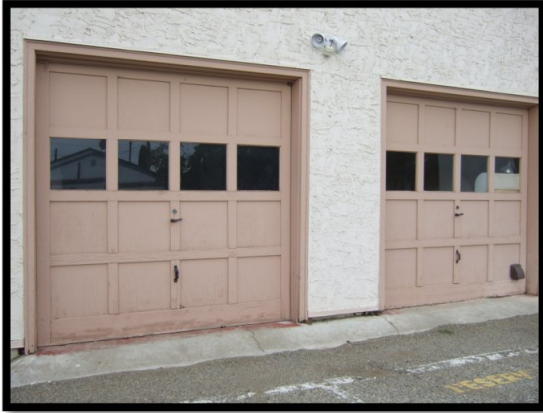
Photo 94: Art Gallery – Bay door entrance

Another potentially accessible entrance is the bay doors which open at the back of the ceramics room. Because of the age and condition of the bay doors, they are opened very infrequently. According to staff it takes about three people to open these, and they have to move around a lot of shelving to make it possible.

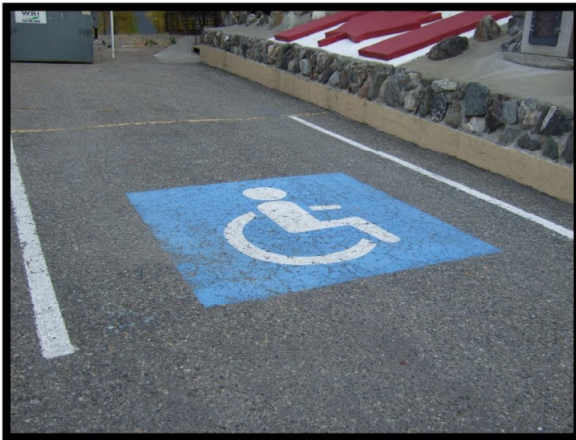
Photo 97: Osoyoos Seniors Centre – Accessible parking stall

There are three accessible parking stalls in the parking lot. Accessibility could be enhanced by improving visibility of parking stalls by providing a sign on a post, and in some cases repainting the painted symbol within the stall. This makes it less likely that people will accidentally park in these stalls.

Recommendation: Improve signage on accessible parking stalls

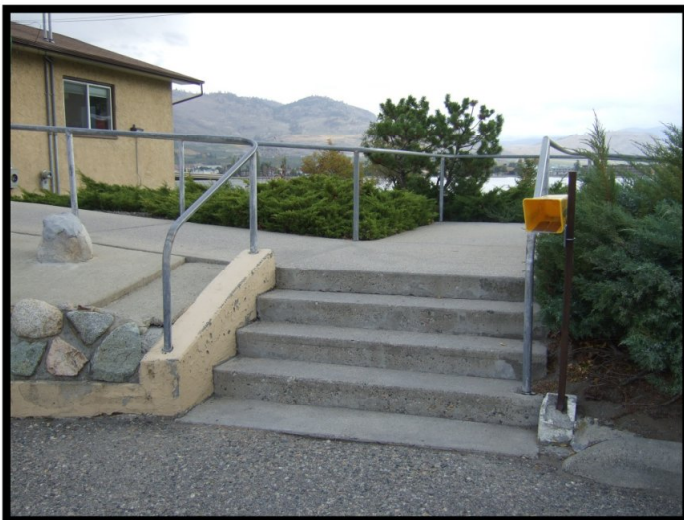
Photo 98: Osoyoos Seniors Centre – Staircase

The current staircase by the entrance lacks tactile warning strips on the stair nosings which warns people with low vision about a change in elevation. According to the Canadian National Institute for the Blind (CNIB), nosings should have a colour/brightness contrasted strip, a maximum depth of 50 mm, and be applied to the leading edge of the tread and the vertical face of the nosing.

Recommendation: Add tactile warning strips to staircase

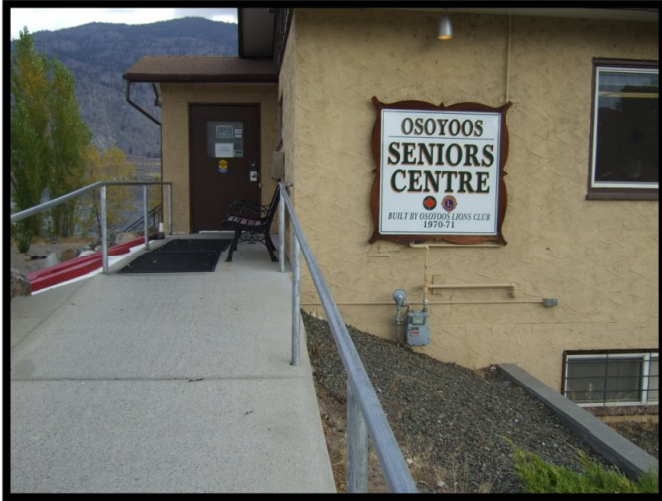
Photo 99: Osoyoos Seniors Centre – Accessible ramp and automatic door opener

Key finding: Main entrance is relatively accessible

The main entrance to the Seniors Centre is relatively accessible since it has a gradual ramp leading up to it as well as an automatic door opener.

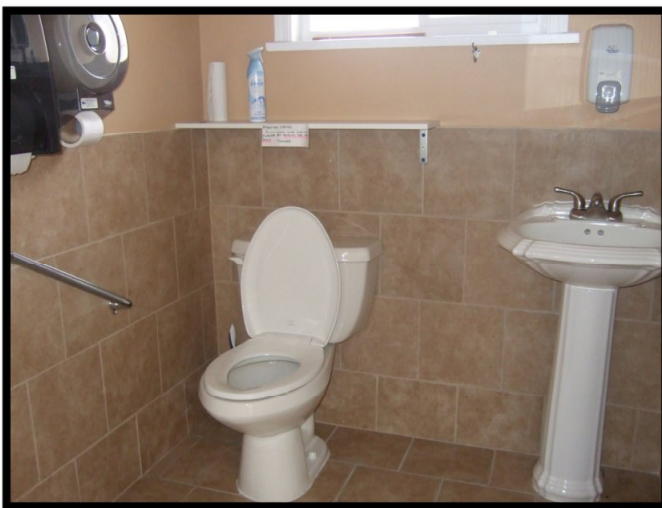
Photo 100: Osoyoos Seniors Centre – Accessible washroom

Key finding: Newly renovated upstairs washrooms meet a high level of accessibility

The newly renovated upstairs washrooms were built to a high level of accessibility and have accessible features such as grab bars, lever handles, knee space under the sink and sufficient space for wheelchairs to maneuver. The only limitation is that the toilet paper is a bit challenging to reach. It is recommended that this be moved to be closer to the toilet.

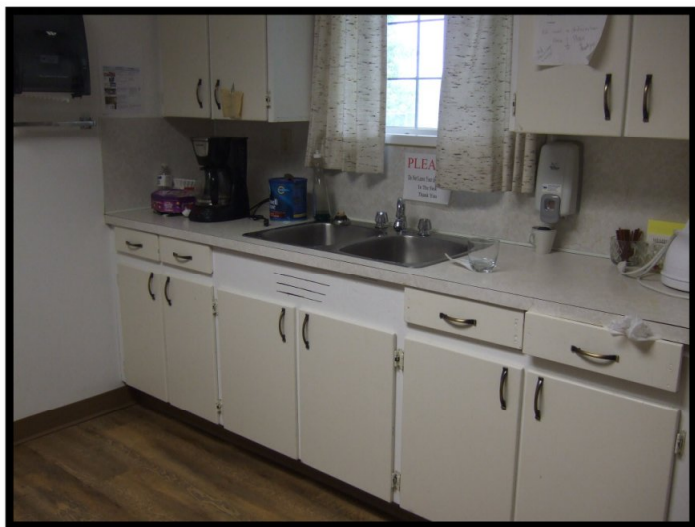
Photo 101: Osoyoos Seniors Centre – Upstairs kitchen

The accessibility of the sink could be enhanced by providing knee space underneath the sink that allows someone with a wheelchair to wheel underneath. In addition, it is recommended that the water faucet handles be replaced with lever style handles which are easier to use for someone with limited hand strength and dexterity.

Recommendation: Provide knee space under the sink and lever handles for the sink faucets
